<b>DELKIN DEVICES</b>		<b>Quality Notice</b>	
DEPT: Quality	DOCUMENT NO.	414-0002-00	
PRINT DATE: 12/4/2017	REV	A	Page 1 of 1

Delkin BLACK UHS-II SD in Sony α7R III fit issue

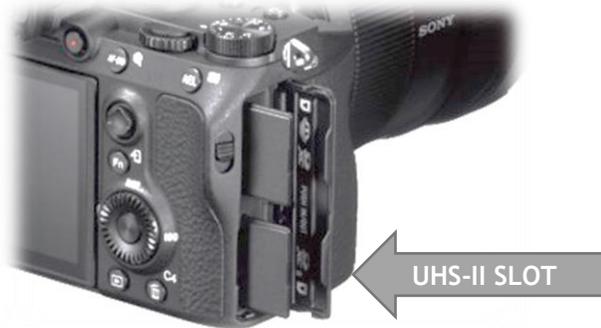
Sony α7R III (UHS-II slot only)

The above UHS-II SD Cards stick in the Sony α7R III's UHS-II slot and are difficult to remove.

When the card is ejected from the UHS-II slot, the camera's connector springs push the card's built-in ruggedizing features against the inside of the connector. The high level of friction may feel as if the card is stuck and may require some force to remove the card. Another possible issue is that any burrs or roughness on the inside of the connector may scratch or rub the card's label causing marks on the label.

Exercising the card in the connector a few times will alleviate the issue for most Sony α7R III cameras.
